CUSTOMER PRODUCT SAFETY NOTICE

Easy Access Attic Ladder- OX-AAL27 or OX-TAL28 - Sold before August 2017

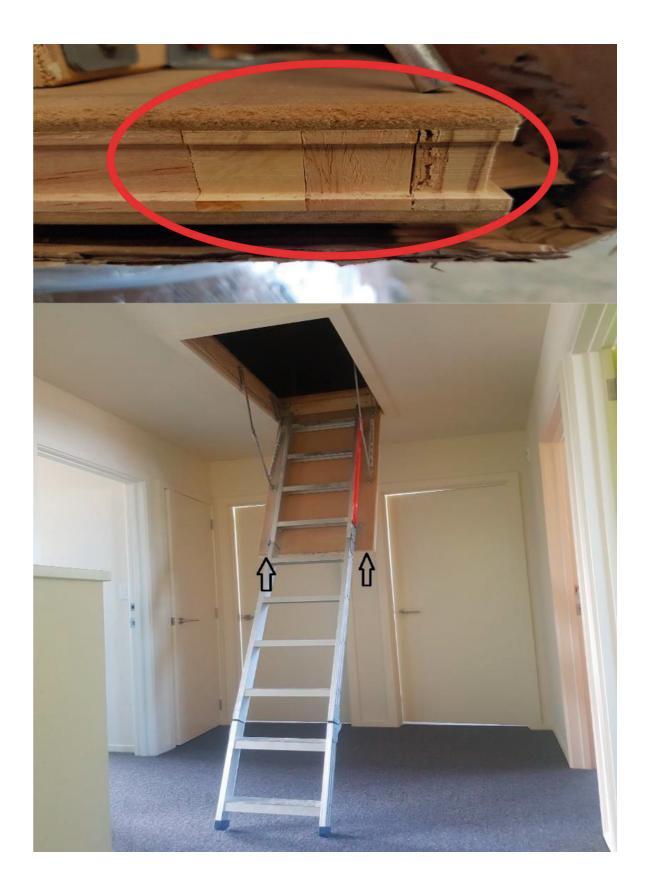
STEP 1:

Lower the base of the timber attic ladder and check that the backing timber in the frame is laminated.

The arrows in the second photo indicate where to inspect the ladder base frame for laminated timber

NB: If solid timber is used no remediation is required.

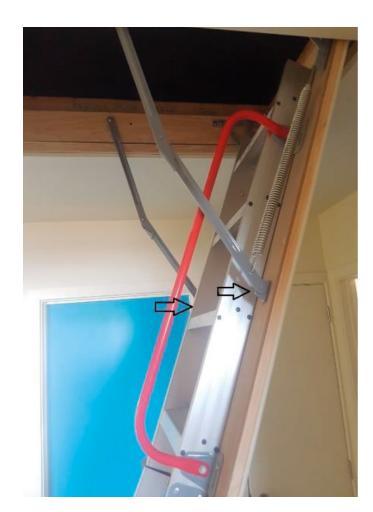
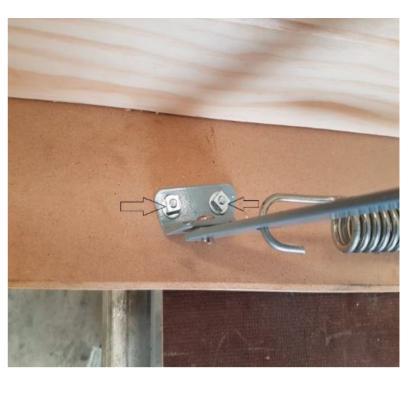
STEP 5:

Insert a M5 x 50 gutter bolt through a plastic 'snap cap', through the base and the side arm mount plate. Tighten a M5 nyloc nut and a washer to the end of the bolt. The arrows in the adjacent photo show the location of the screws at the end of the stay arms.

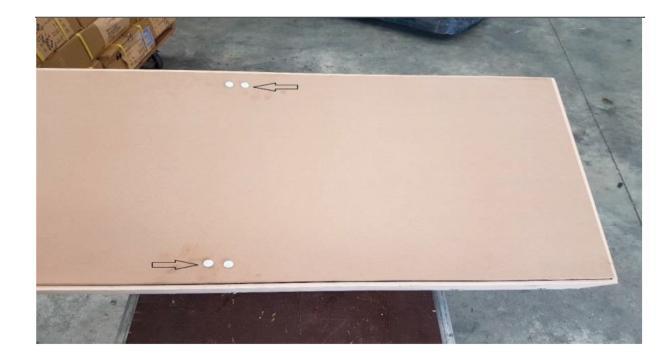
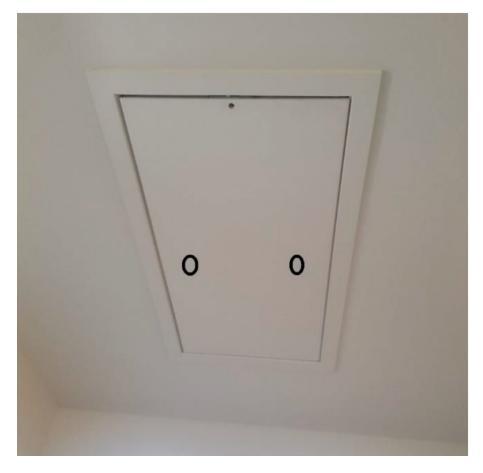
STEP 6:

Insert the 'snap cap' covers over the head of each bolt. The photo adjacent shows the caps on an unpainted base. The 'snap caps' will blend in well with typical ceiling colour. The circles in the second photo show their approximate location.
